South Florida Ecosystem
Restoration Task Force
June 29, 2016

Environmental Conditions Update

Water Resources Division Director
South Florida Water Management District

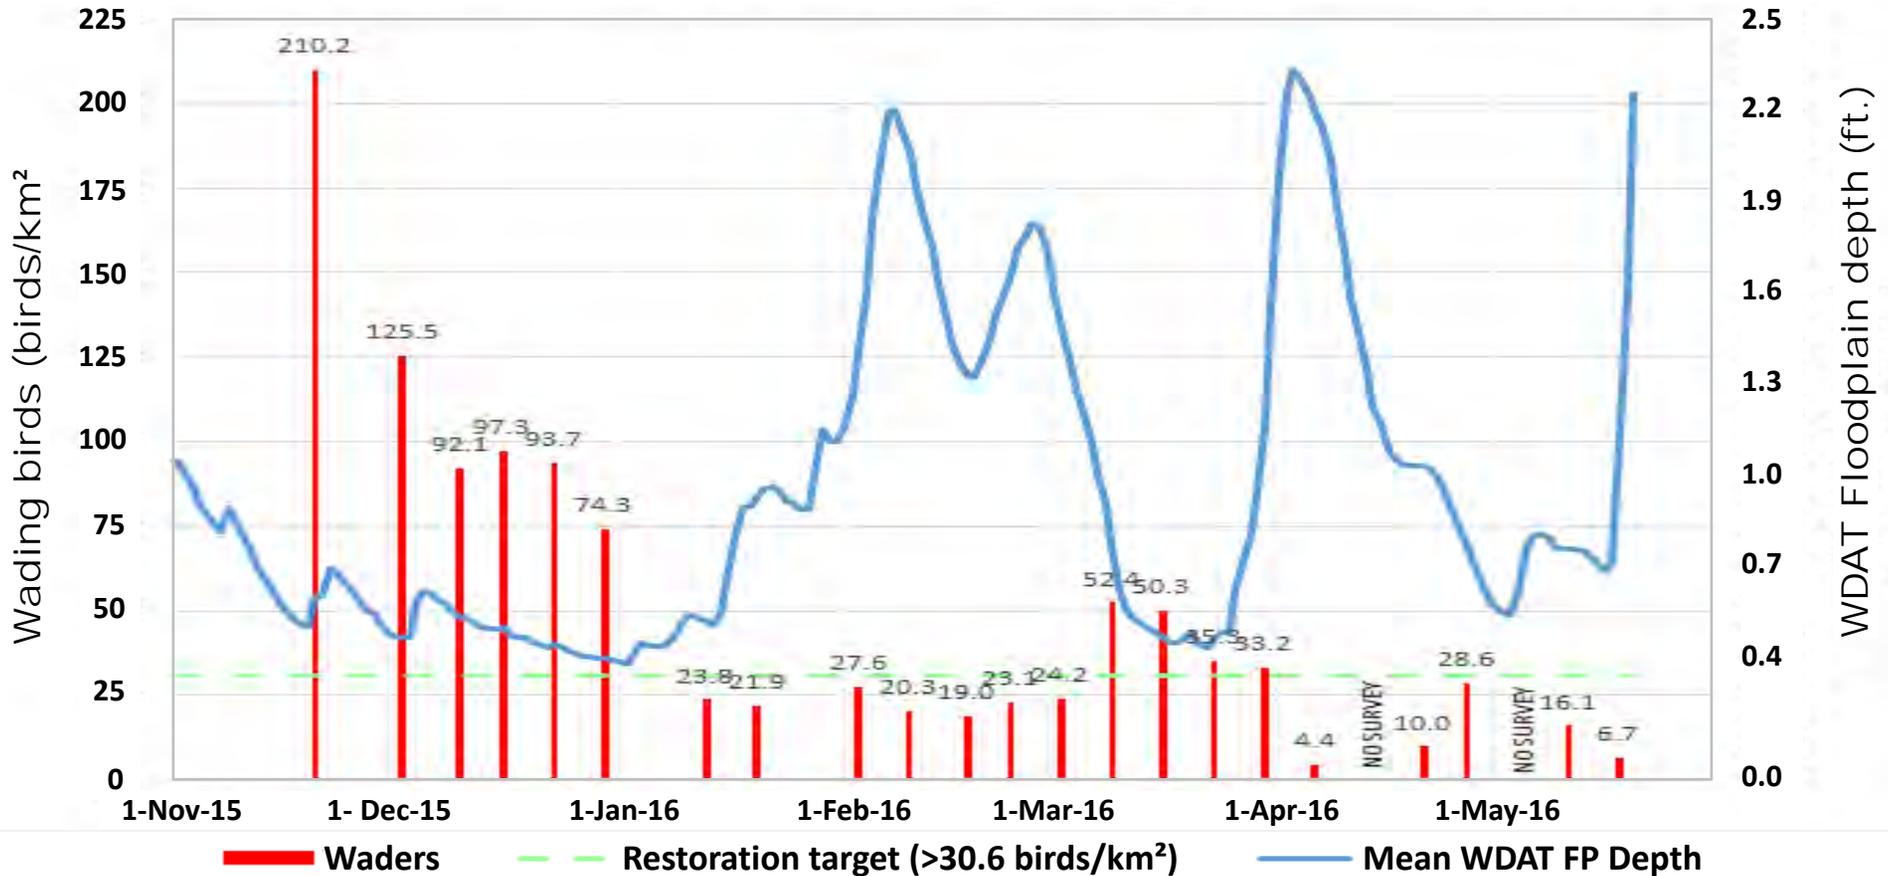
Wading Bird Abundance vs. Mean Floodplain Depth Phases I, IVA, and IVB

- Stage reversals (increases in water depth) on the Kissimmee River floodplain are caused by increases in flow at S65/S65A following rainfall
- Increases in floodplain water depth affect the ability of wading birds to use floodplain habitats because they cannot forage in water that is too deep

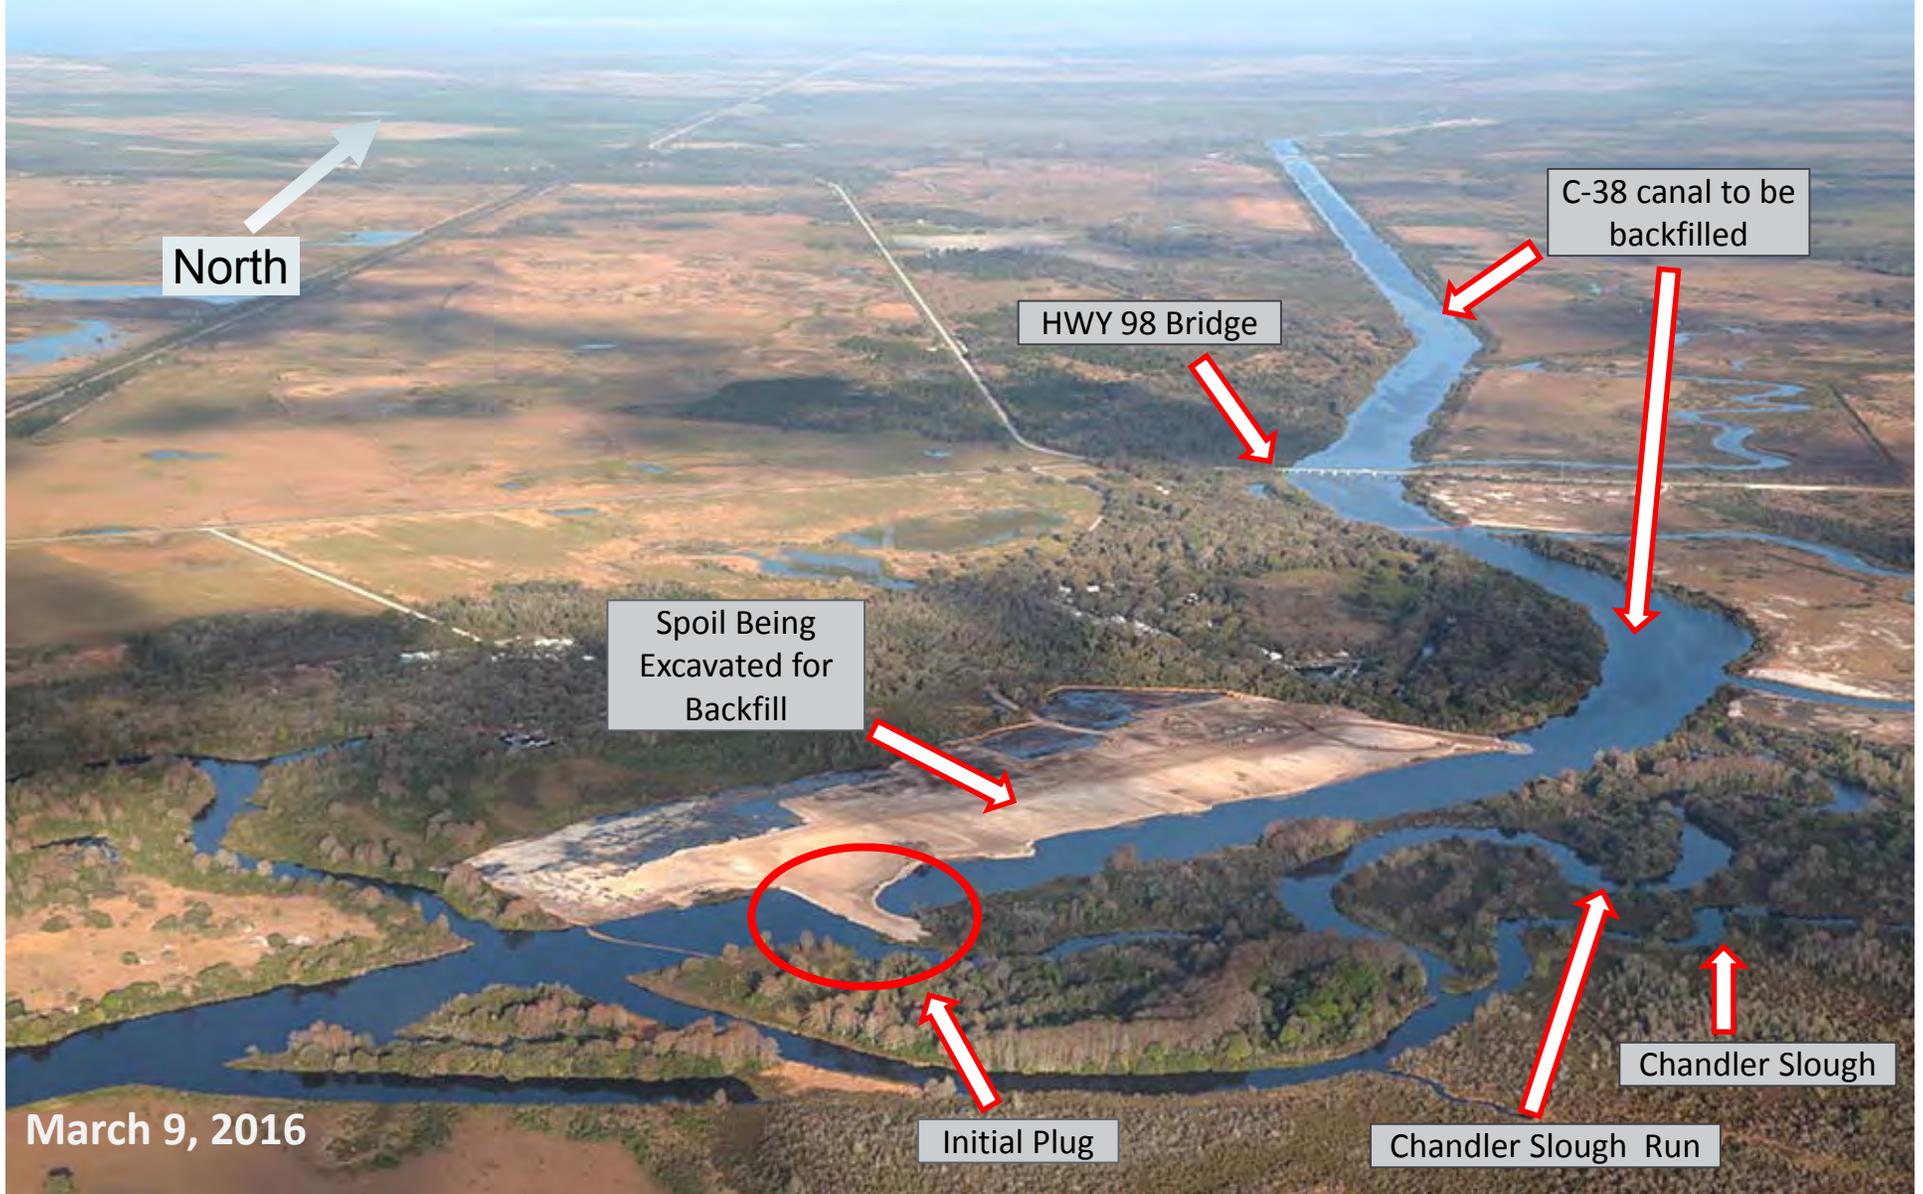
March 9, 2016

Kissimmee River Phase/Reach 3 restoration area looking northwest. Contractors have successfully completed the initial plug of C-38 reach 3 backfill. They will now continue their way northwest backfilling the canal. Phase/Reach 3 continues upstream to HW98 bridge. Phase/Reach 2 will continue further upstream to connect with Phase/Reach 1 backfill completed in 2001

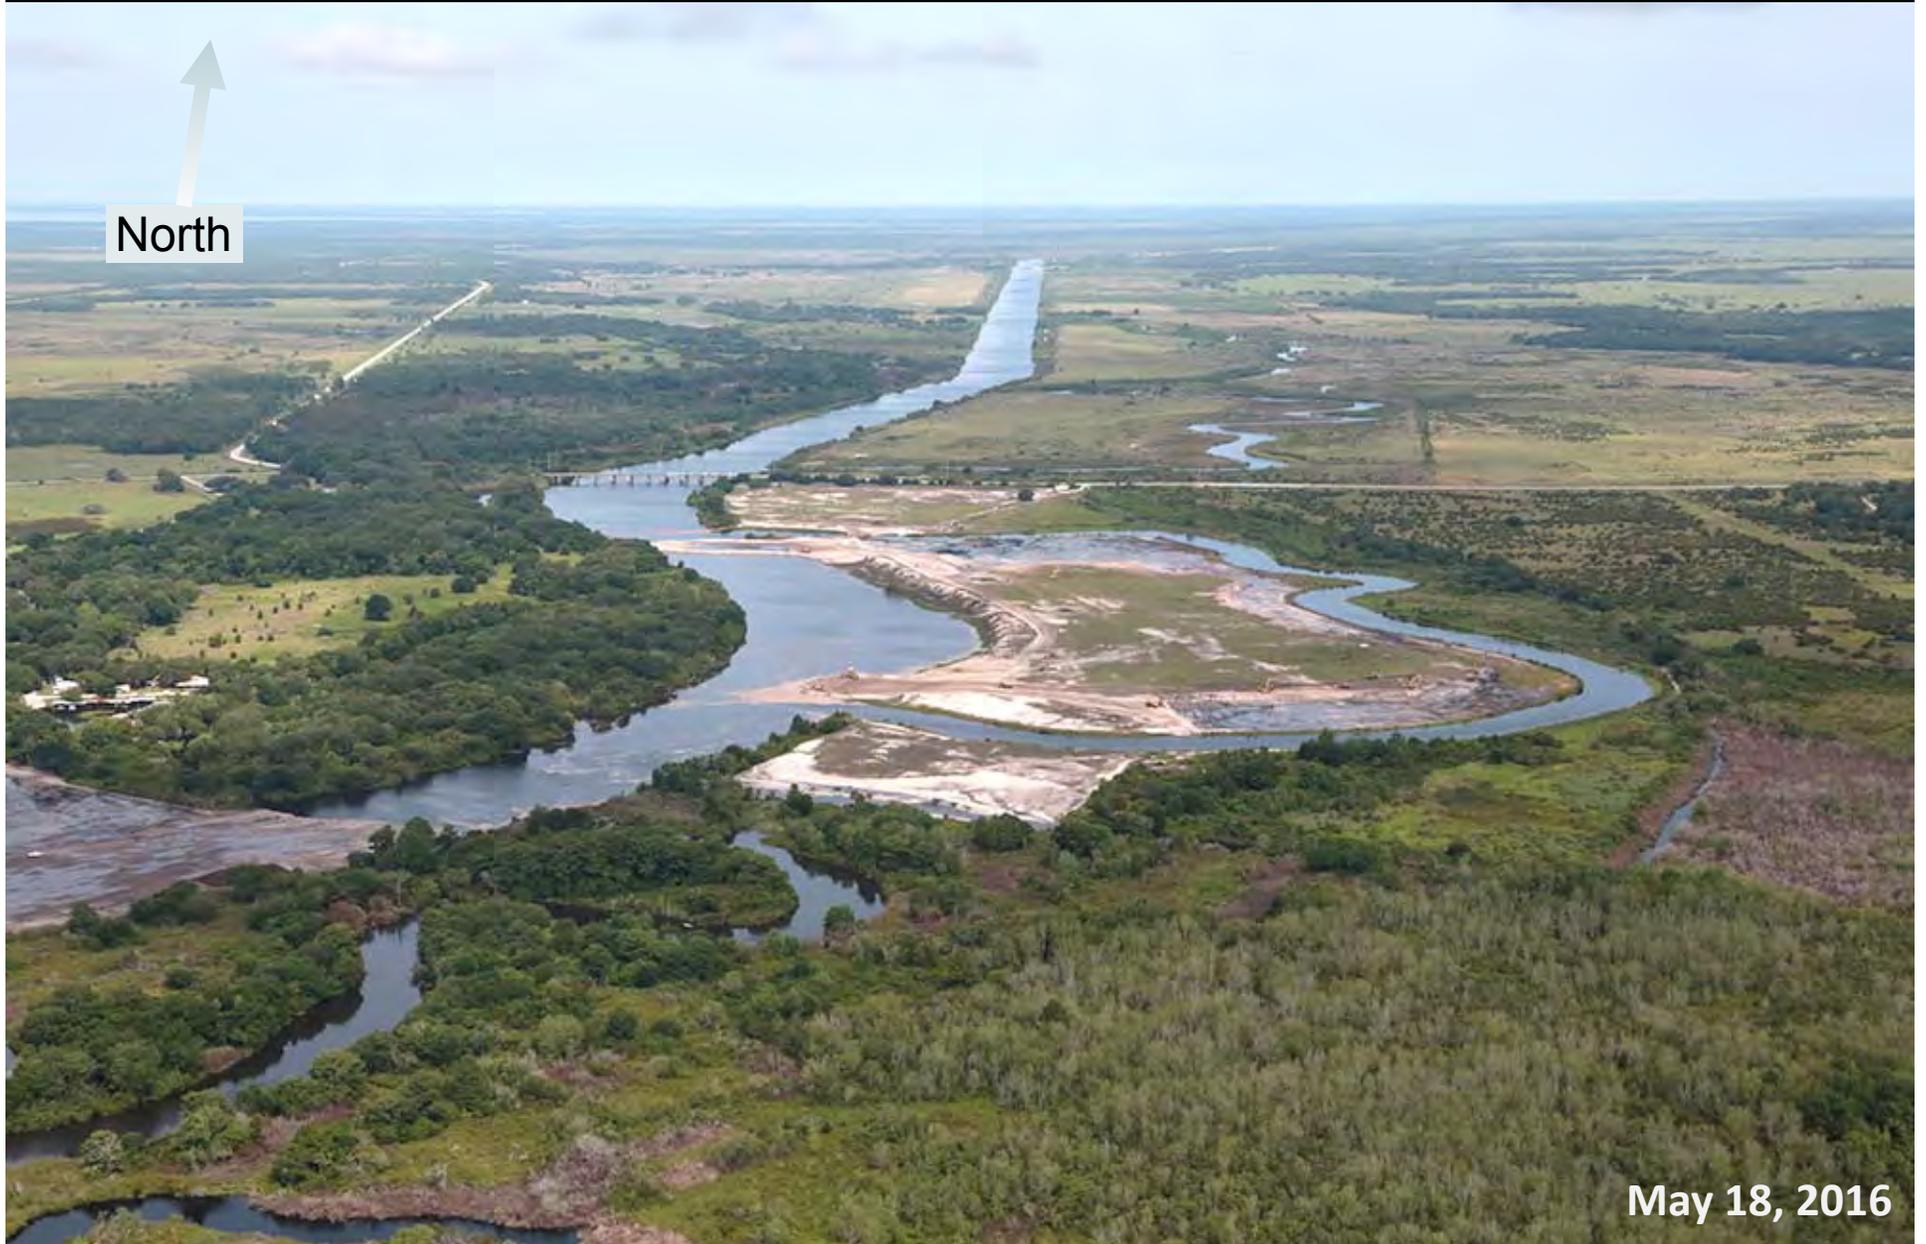
May 18, 2016

Kissimmee River Reach 3 restoration area looking north up the C-38 where a plug is being placed at the north end of reach 3 just south of the HW98 bridge

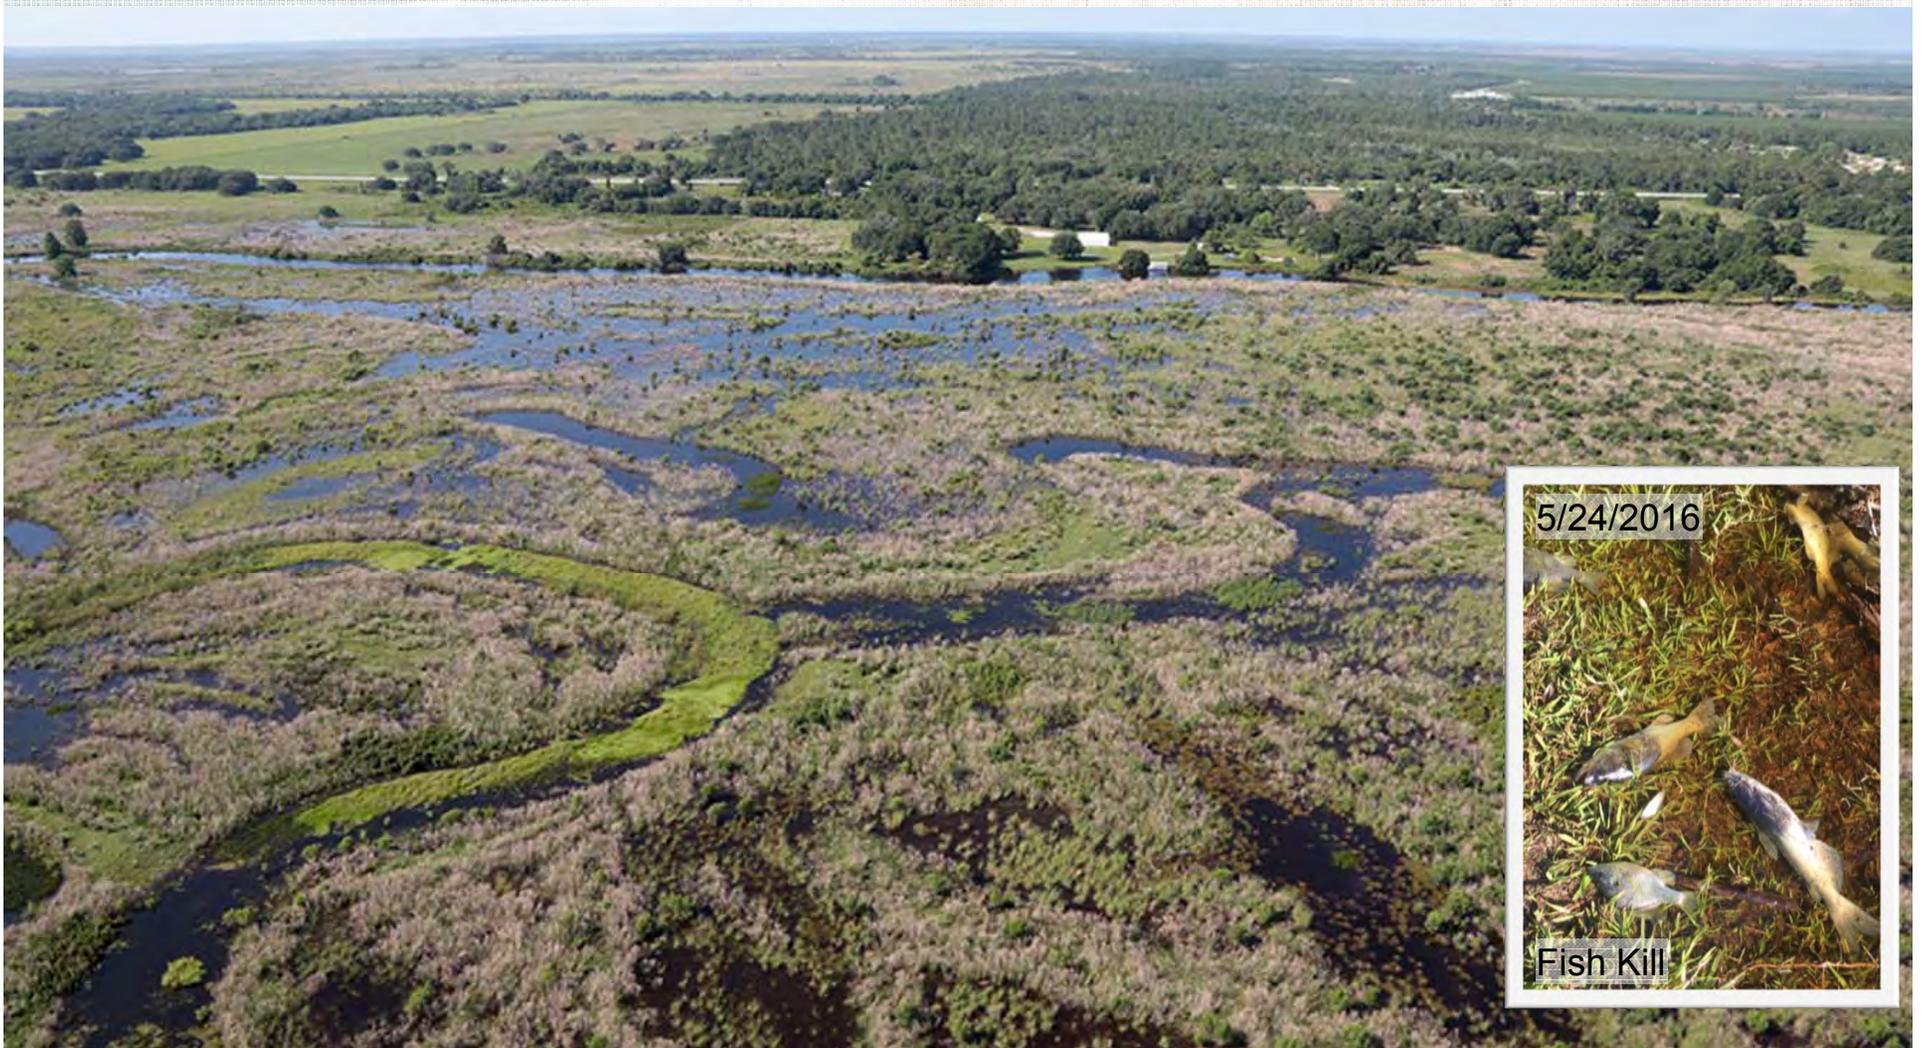
Looking across the Phase II/III floodplain on 5/25/2016

Phase II/III Floodplain First Flood Event in 45 Years and Fish Kill

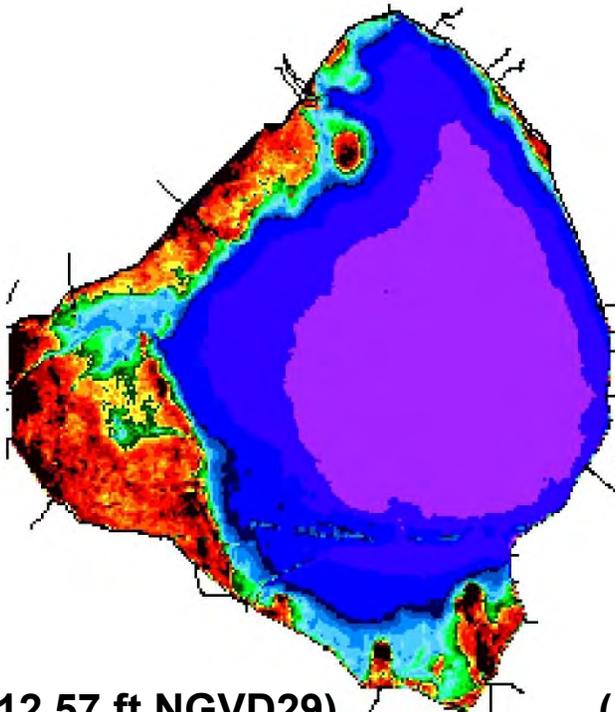
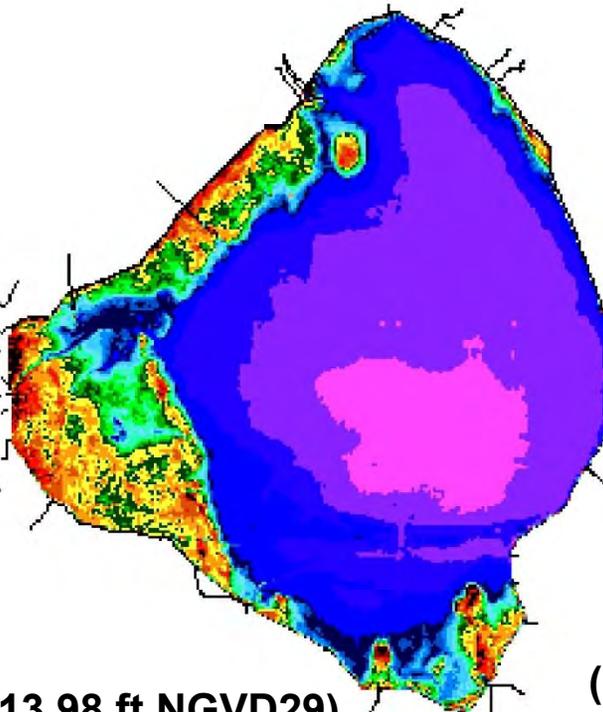
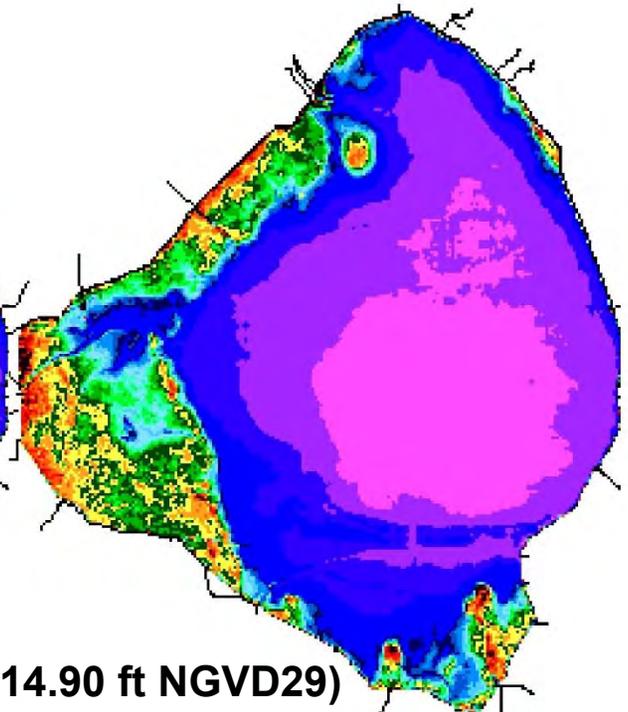
Depth Map: 06/06/2016

(12.57 ft NGVD29)

(13.98 ft NGVD29)

(14.90 ft NGVD29)
Current Lake Stage

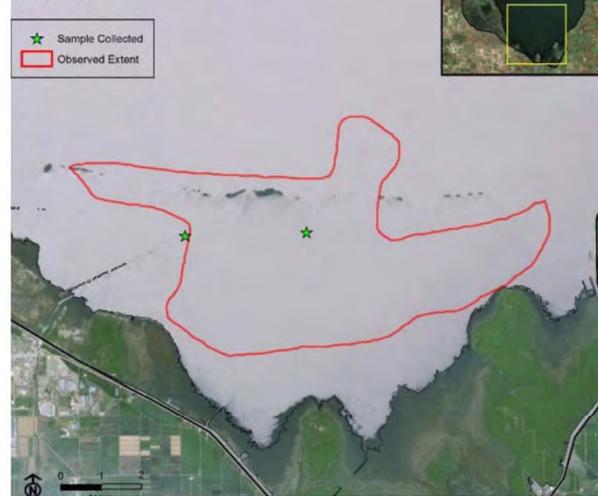
Lake Okeechobee
Algal Bloom Observed
May 9, 2016

- Large blue green algal bloom reported on May 9th
- Bloom conditions persist across the lake
- Lake Okeechobee algal blooms strongly associated with higher lake stages
- Elevated nutrient levels are principal cause of blooms, but other factors include warm temperatures & stagnant conditions

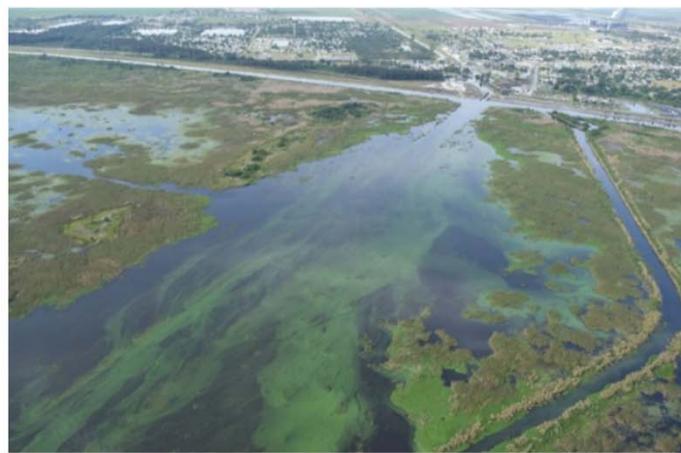
Lake Okeechobee looking south to Clewiston
May, 2016

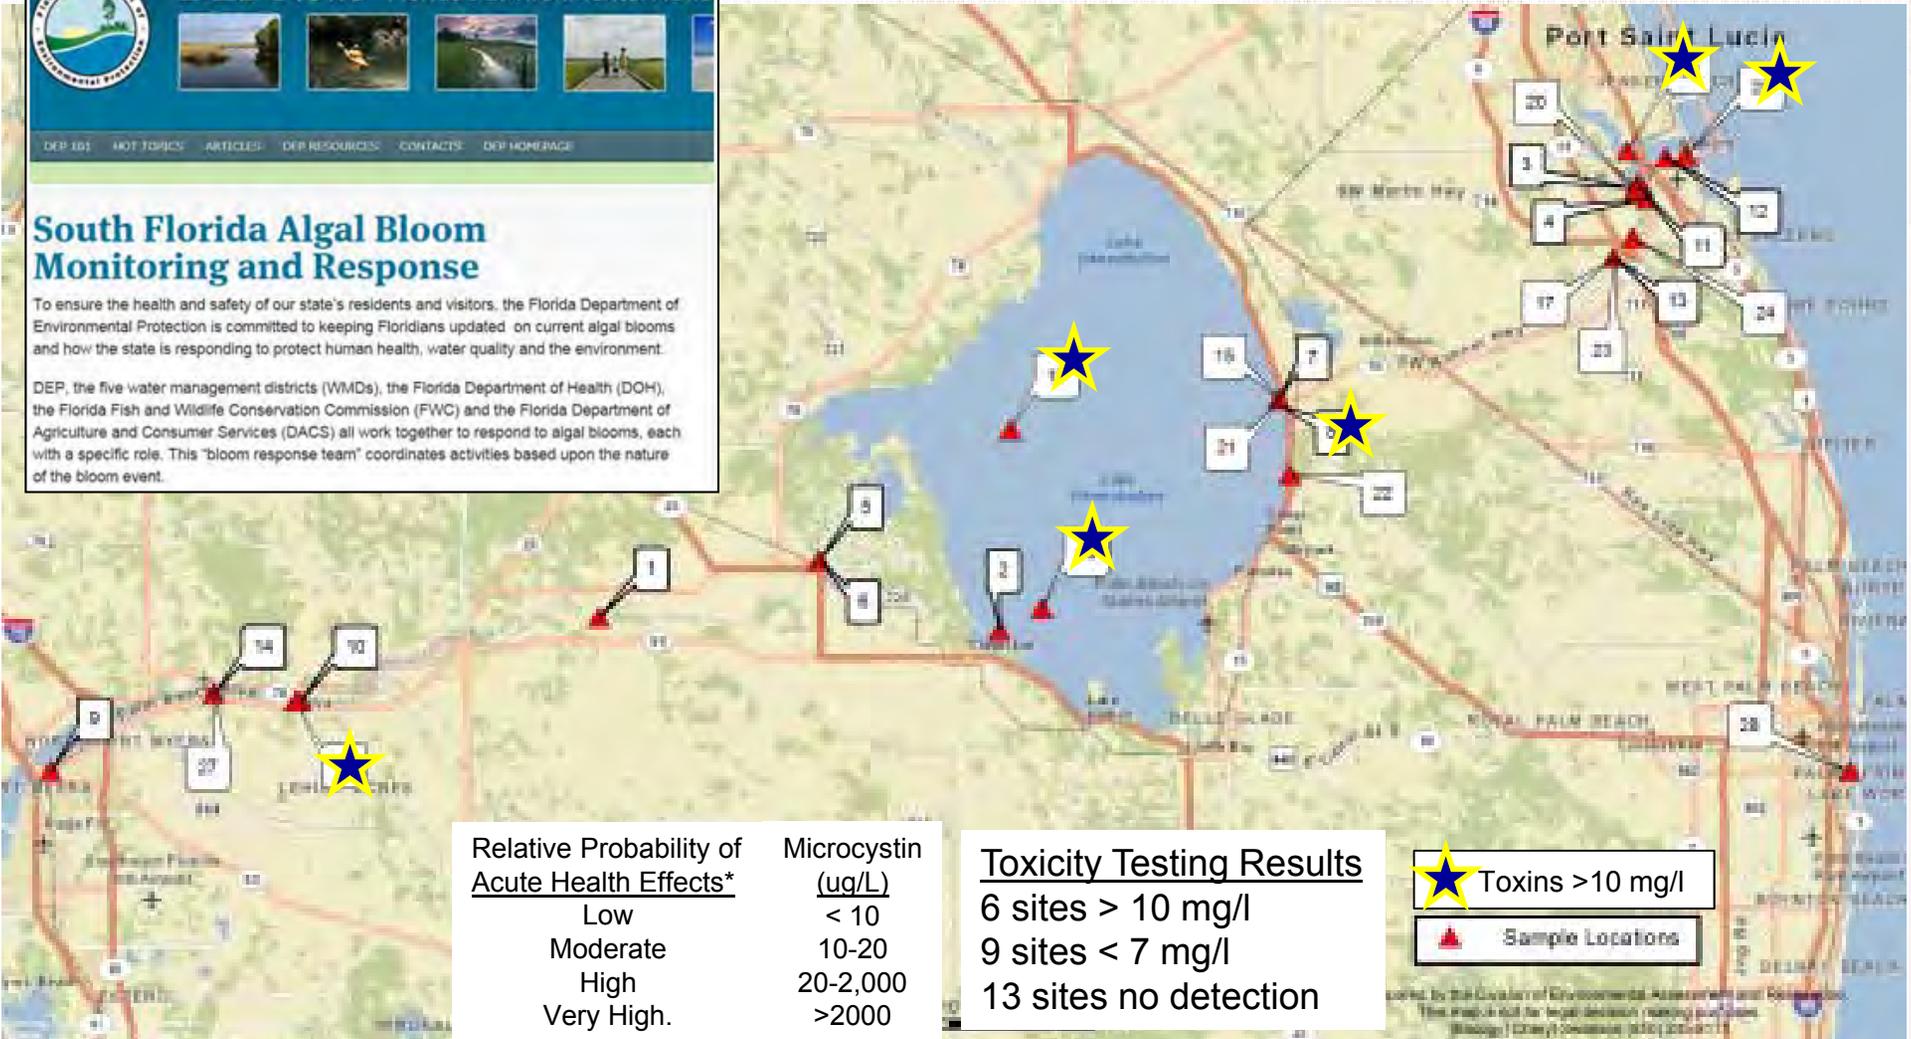
Relative Probability of Acute Health Effects*	Microcystin (ug/L)
Low	< 10
Moderate	10-20
High	20-2,000
Very High.	>2000

Toxicity Testing Results
 6 sites > 10 mg/l
 9 sites < 7 mg/l
 13 sites no detection

Toxins >10 mg/l

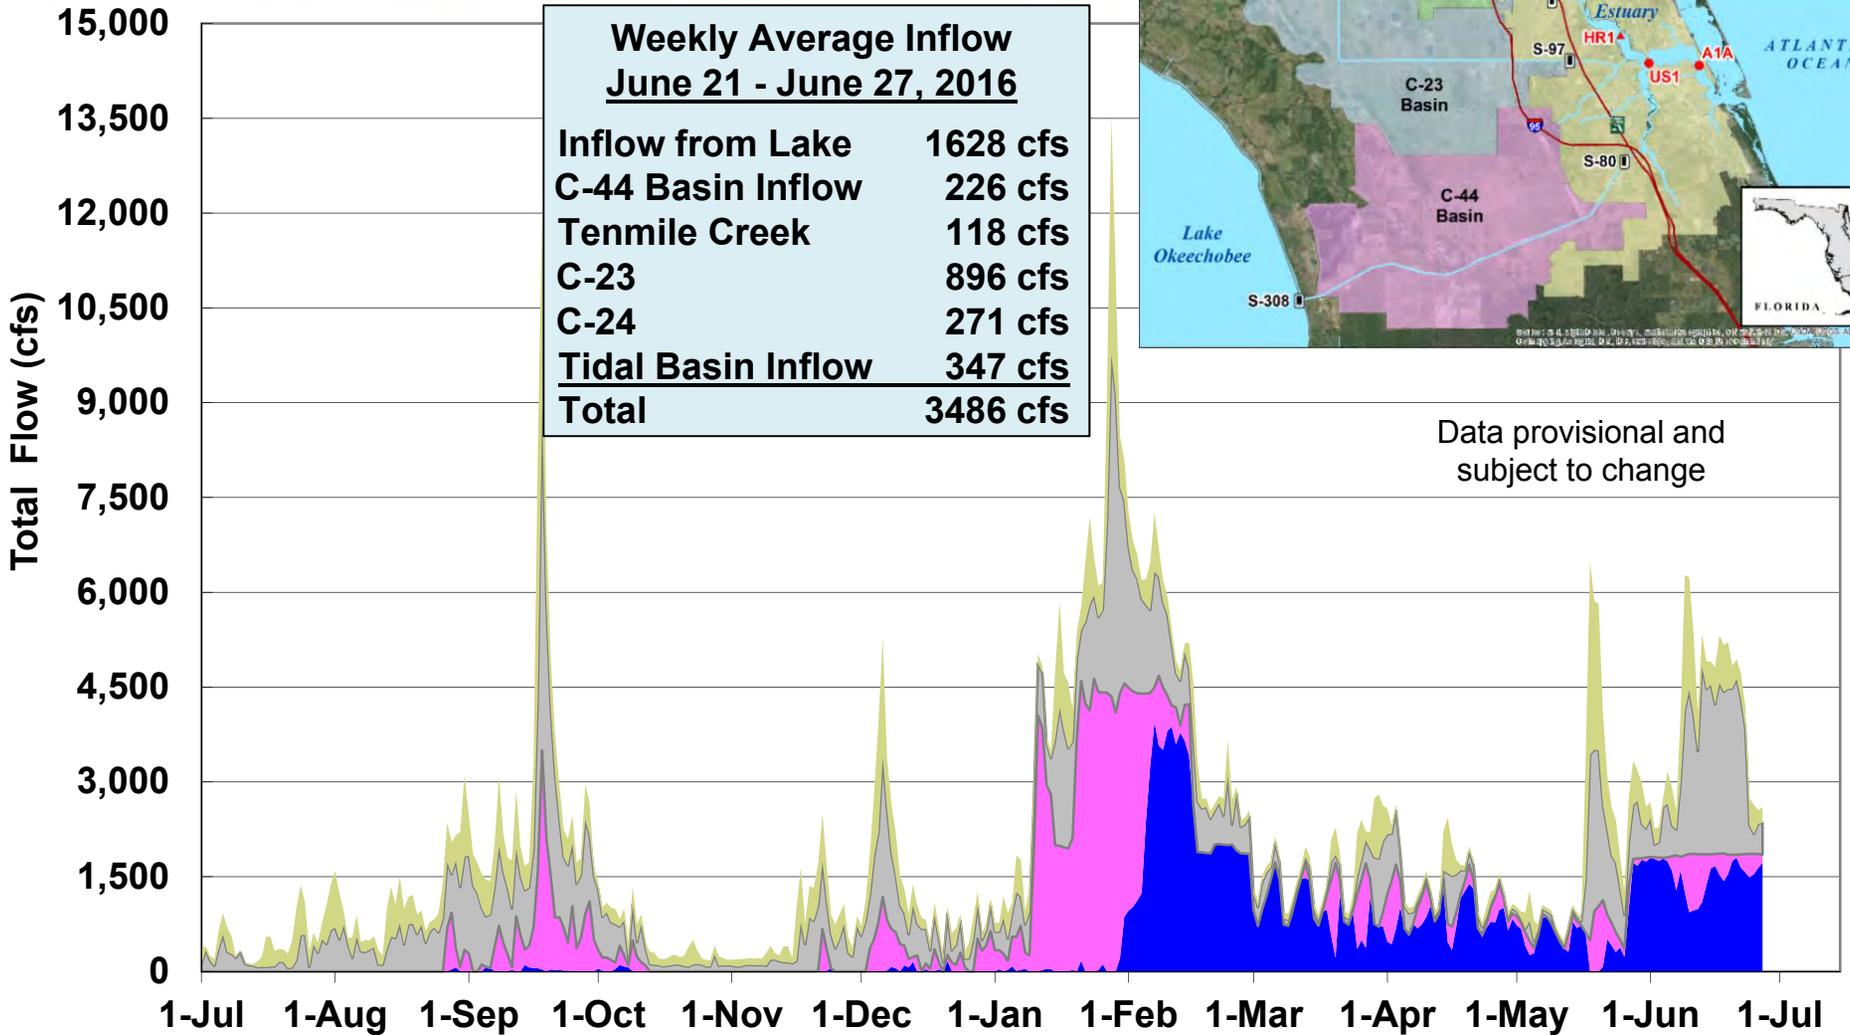
**Weekly Average Inflow
June 21 - June 27, 2016**

Inflow from Lake	1628 cfs
C-44 Basin Inflow	226 cfs
Tenmile Creek	118 cfs
C-23	896 cfs
C-24	271 cfs
Tidal Basin Inflow	347 cfs
Total	3486 cfs

■ Inflow from Lake* (using downstream gauge)
 ■ C-44 Basin Runoff
 ■ Inflow from C-24, C-23, and Tenmile Creek
 ■ Tidal Basin Inflow

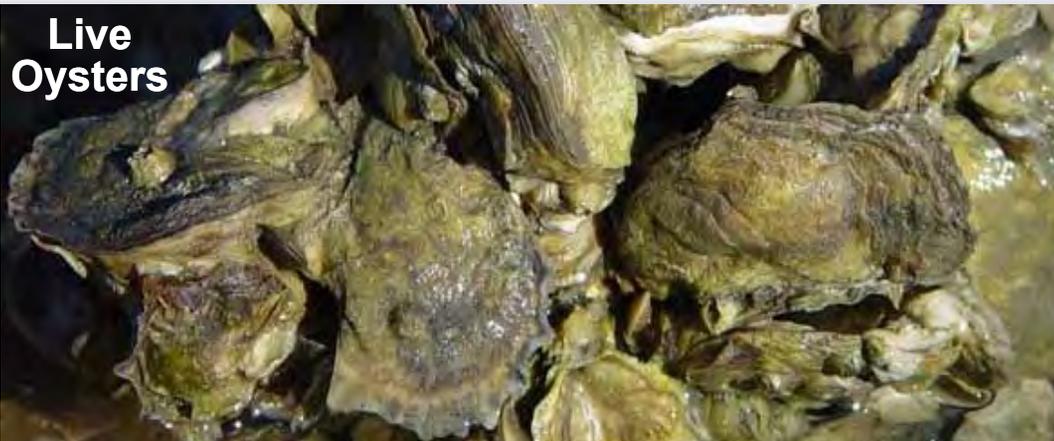
Seven day mean salinity of the water column at US1 Bridge in the St. Lucie Estuary

St. Lucie Estuary Salinity

Live Oysters

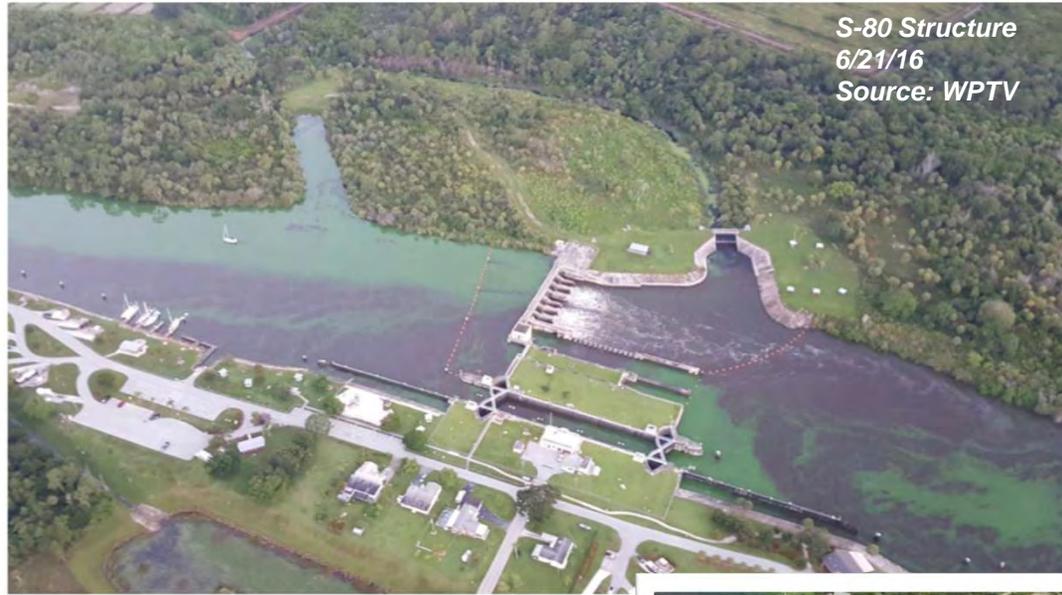
S-80 Structure
6/21/16
Source: WPTV

Widespread Algal Blooms in the St. Lucie Estuary

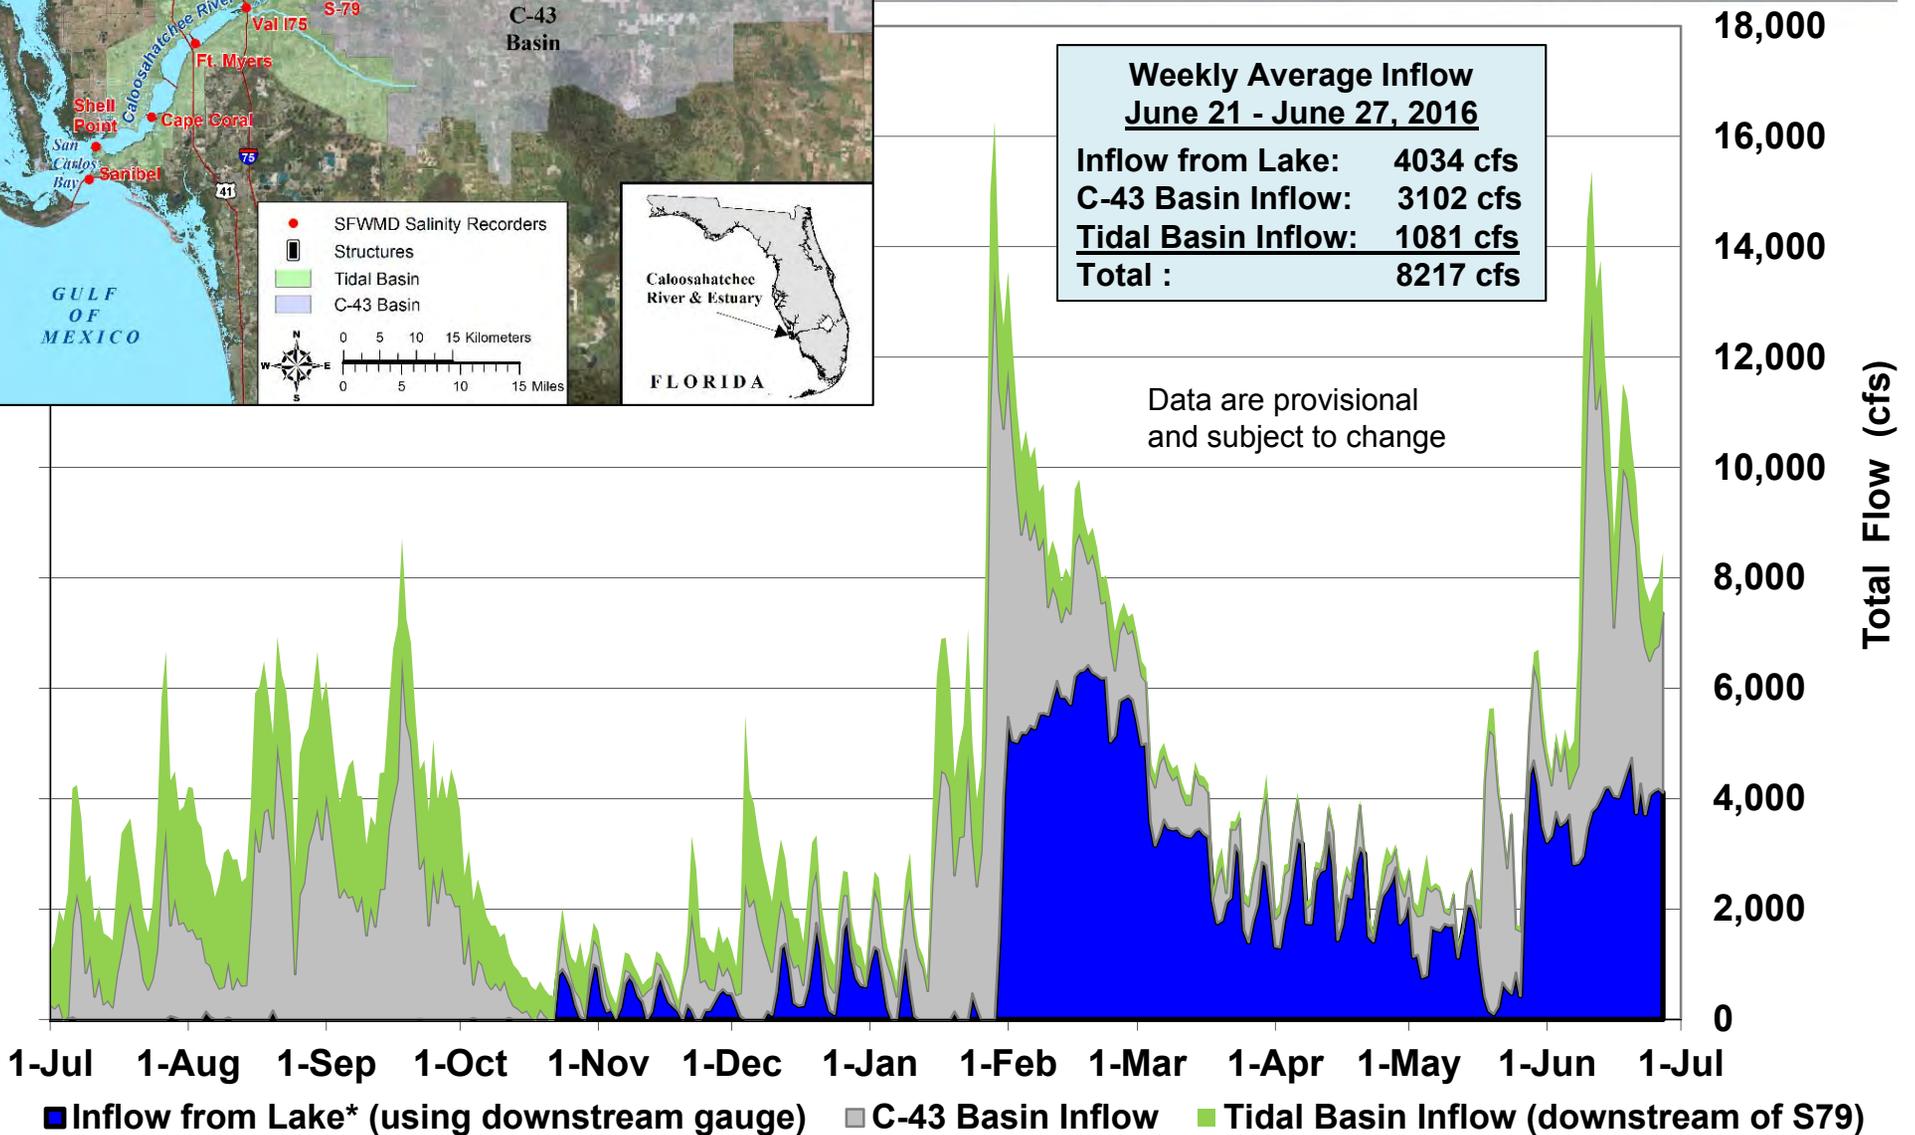
Weekly Average Inflow June 21 - June 27, 2016	
Inflow from Lake:	4034 cfs
C-43 Basin Inflow:	3102 cfs
Tidal Basin Inflow:	1081 cfs
Total :	8217 cfs

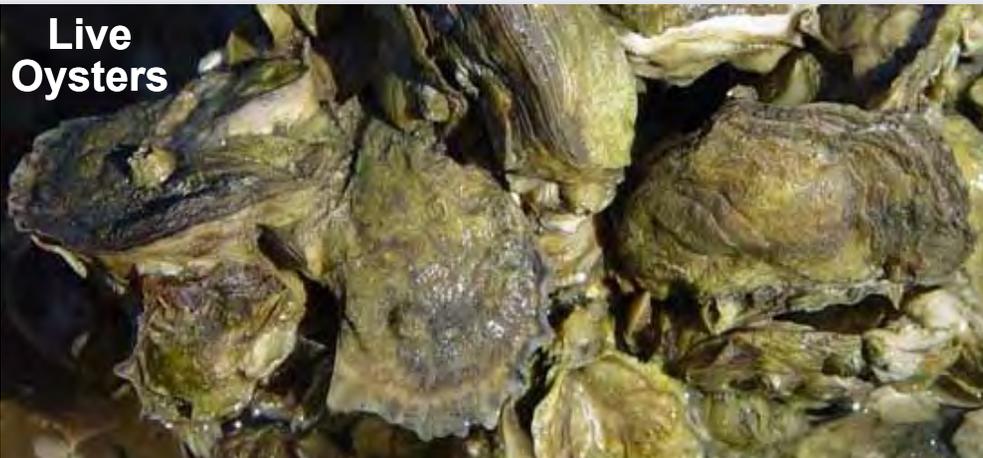
Seven day mean salinity of the water column at 3 monitoring stations in the Caloosahatchee Estuary

Caloosahatchee Salinity

Live Oysters

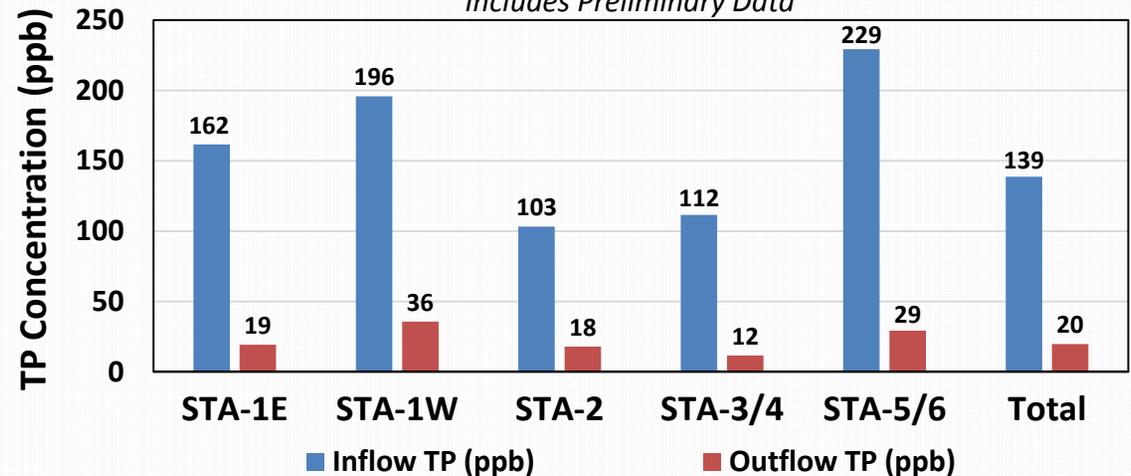
STA Performance Summary WY2016

In Water Year 2016, the STAs achieved a total combined Total Phosphorus (TP) outflow of 20 ppb - despite high inflows during the dry season

STA-1E	STA-1W	STA-2	STA-3/4	STA-5/6	Total
Inflow TP (ppb)	162	196	103	112	229	139
Outflow TP (ppb)	19	36	18	12	29	20
Inflow Vol. (ac-ft)	207,057	155,089	424,209	434,362	145,128	1,365,845

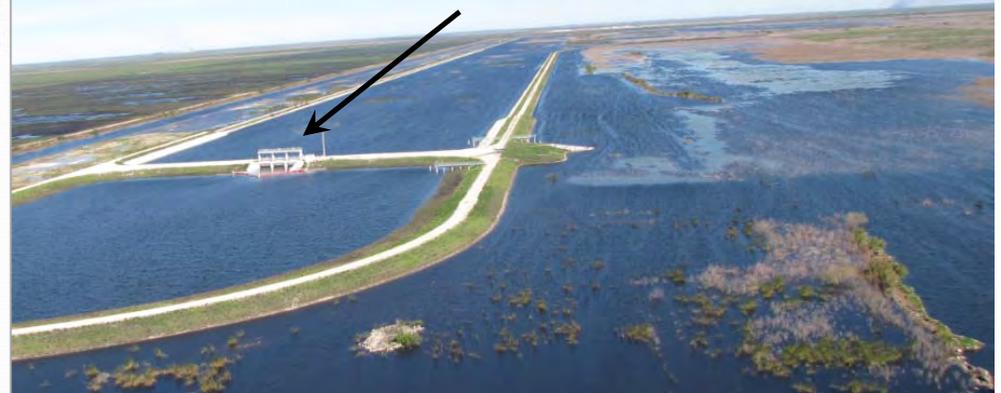
A-1 FEB Inflow Structure G-720

- Most cell depths are at or above target
- A-1 Flow-Equalization Basin (FEB) receiving runoff then discharging to the STAs for treatment and delivery south to the Water Conservation Areas
- A-1 FEB has been reducing TP concentrations by ~60% & TP loads to the STAs by ~80%

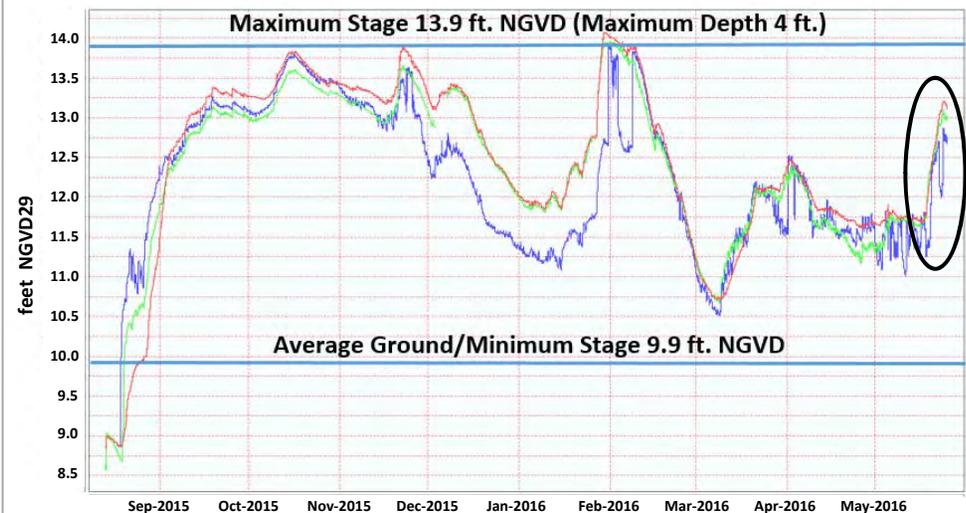
A-1 FEB Stage

STAs received high inflow volumes in May-June

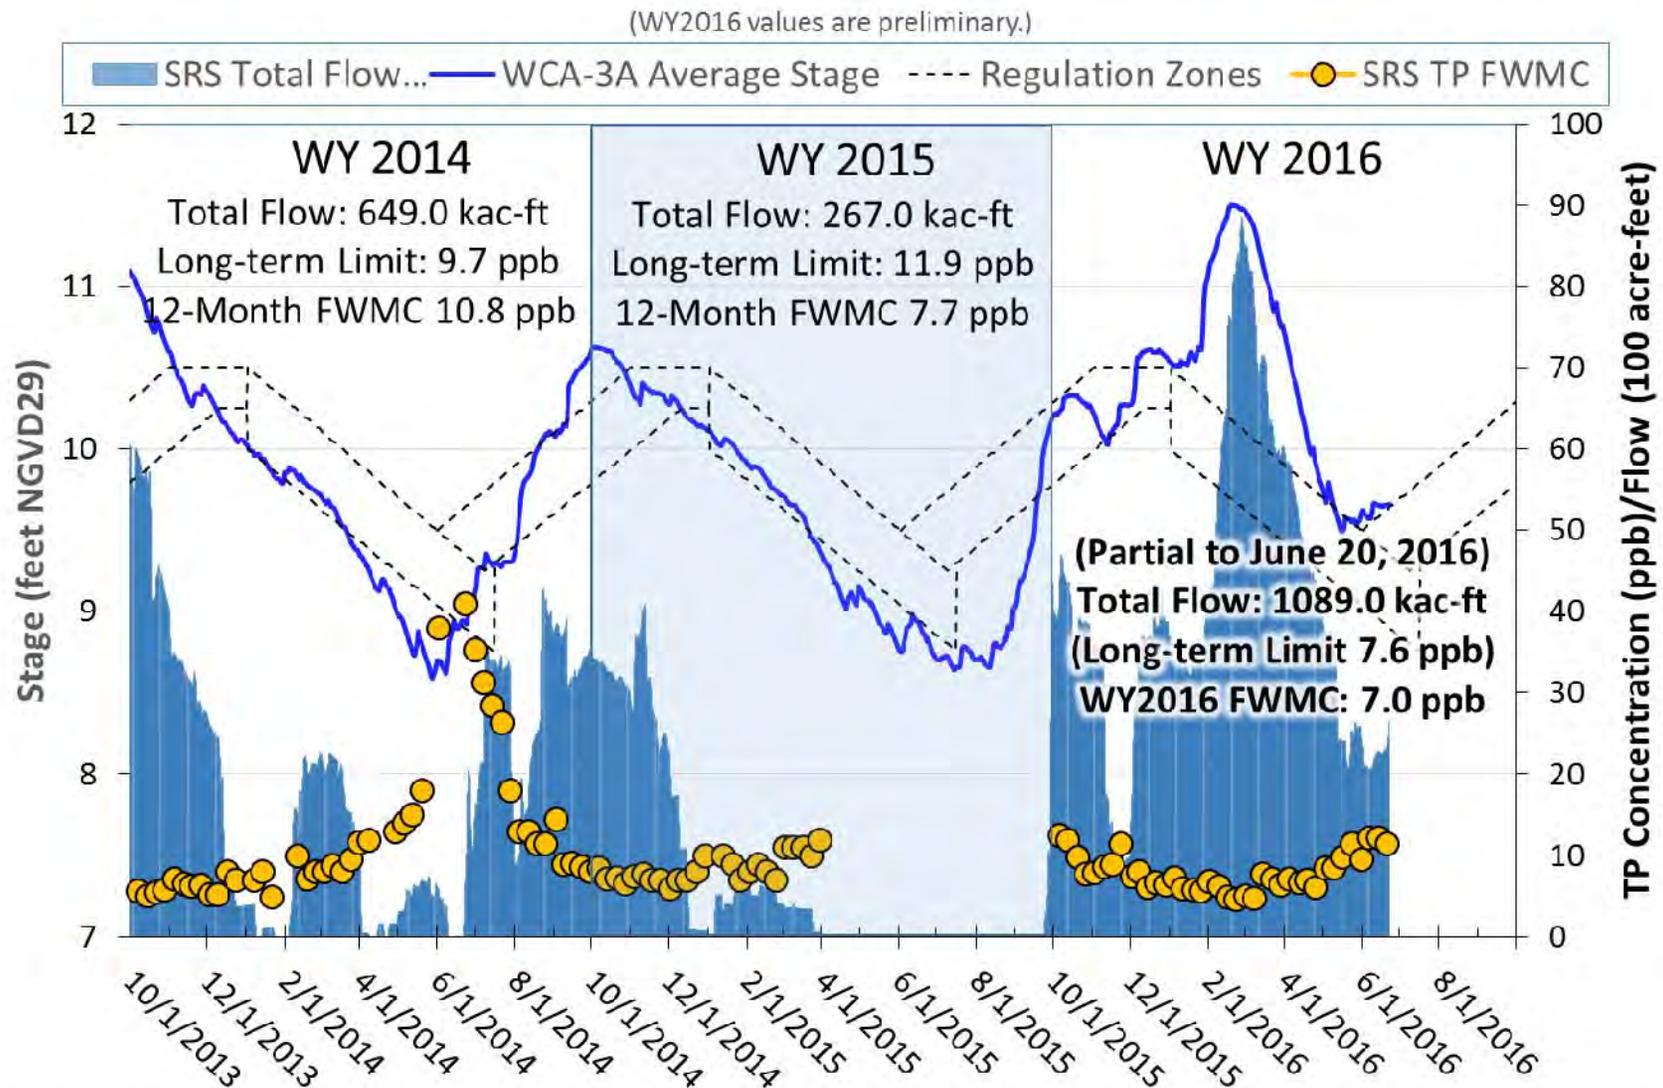
Water Level, Flow & Total Phosphorus Trends Shark River Slough Water Years 2014 – 2016

Kac-ft = Acre-feet x 1000

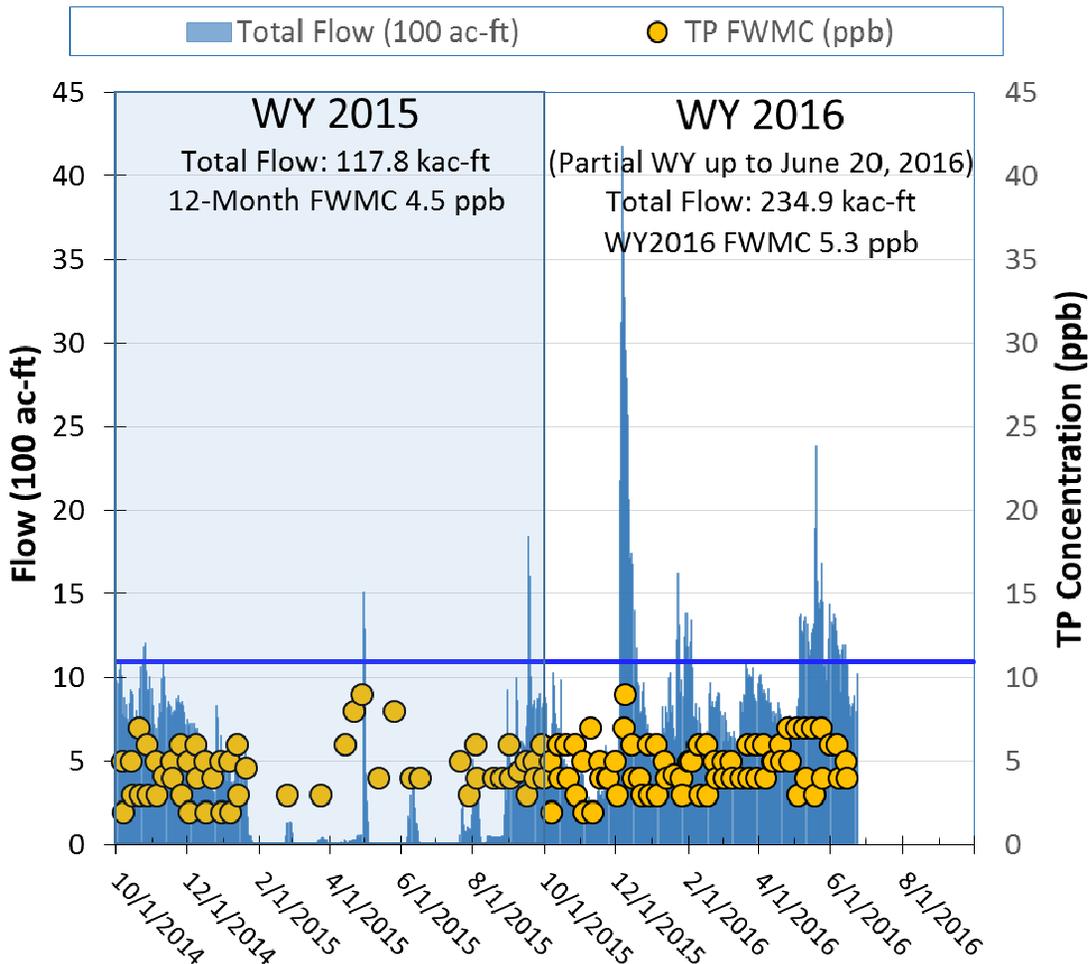
Flow and TP Flow-weighted Mean Concentration to Taylor Slough and Coastal Basins

- Consent Decree compliance for Taylor Slough and Coastal Basins based on annual flow-weighted mean Total Phosphorus concentration
- TP limit fixed at 11 ppb
- TP concentrations appear to be on trajectory for 5 - 6 ppb
- Federal WY2016 ends September 30, 2016 (three months remain in compliance period)
