South Florida Ecosystem
Restoration Task Force
June 29, 2016

Environmental Conditions Update

Water Resources Division Director
South Florida Water Management District

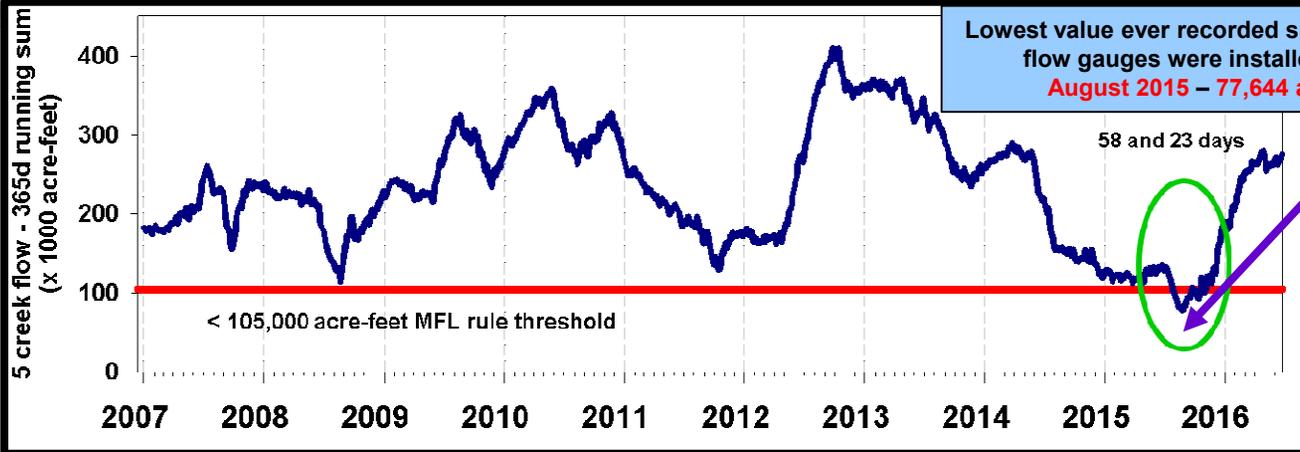
Minimum Flow
105,000 ac-ft
365 day running
sum of 5 creeks

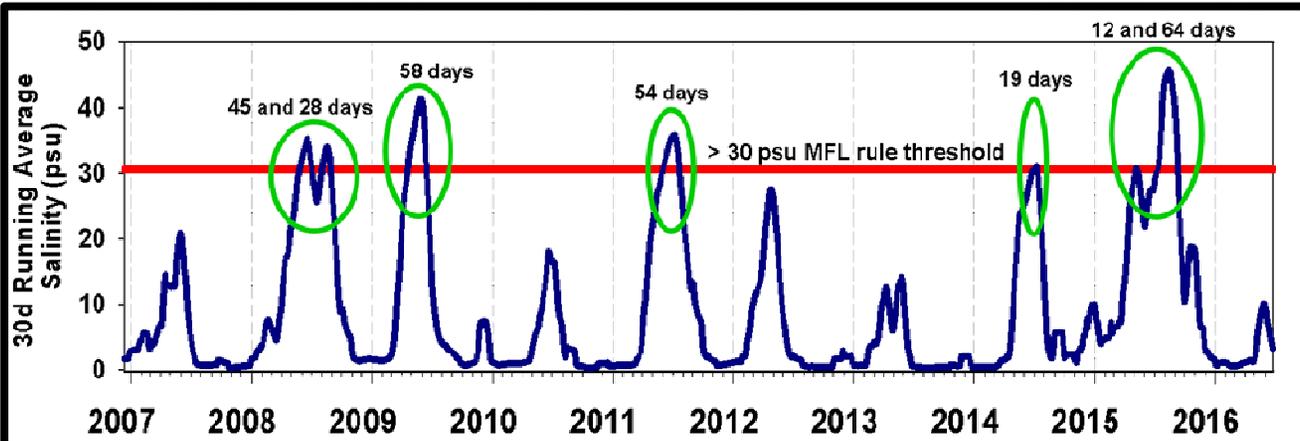
MFL “exceedance”
when 30-day
running average
salinity is > 30 psu

“Violation” occurs with
exceedances during
each of two consecutive
years, more often than
once in a ten-year
period

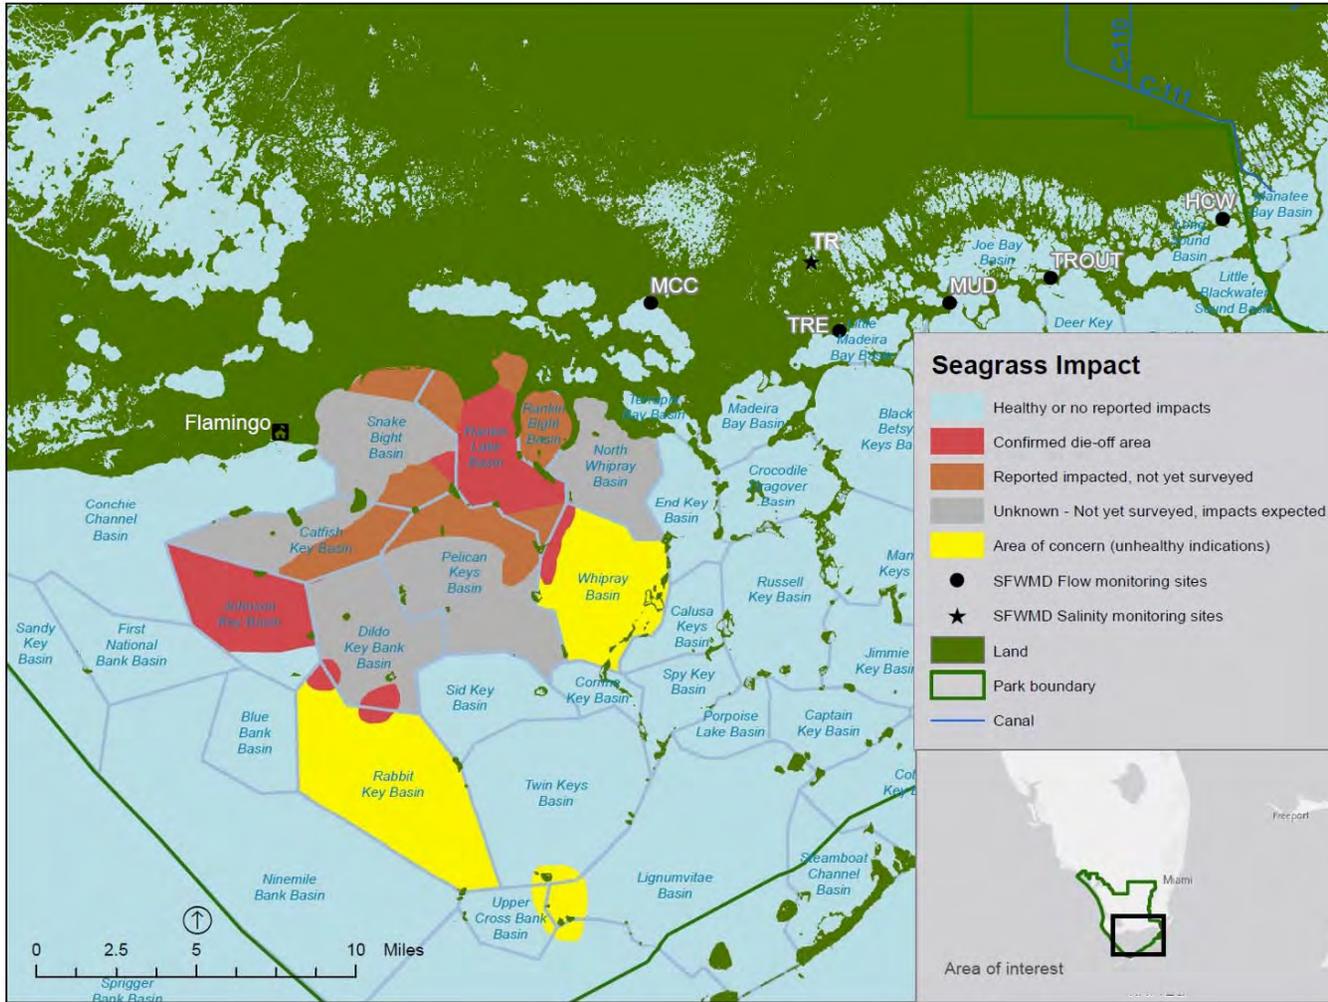
Florida Bay Seagrass Die-off

- Localized drought conditions May 2014 through August 2015
- Reduced rainfall & freshwater inflows, extremes in salinity and temperature
- Die-off of seagrass within estimated 40,000 acres are in central Florida Bay
